Report on Siebtechnik Screen Modifications performed at Roy Hill Iron Ore Mine in March 2016.

Written by: DR Paul Roberts

Date: 29/03/2016

Synopsis: This document summarizes the work performed at Roy Hill Iron Ore Mine during the period 18th to 25th of March 2016 in regard to reformatting 3 by 3000mm x 6000mm vibrating Grizzly Screens

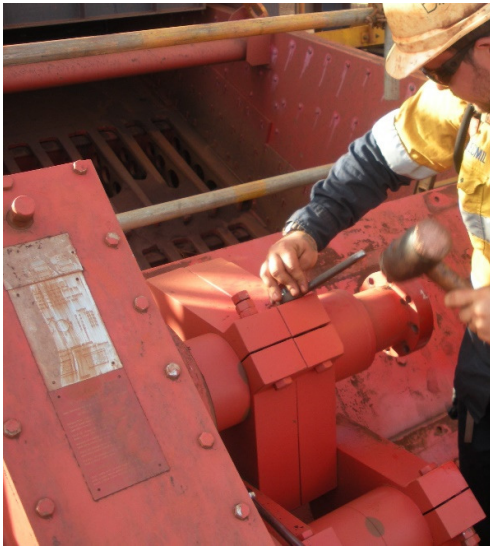
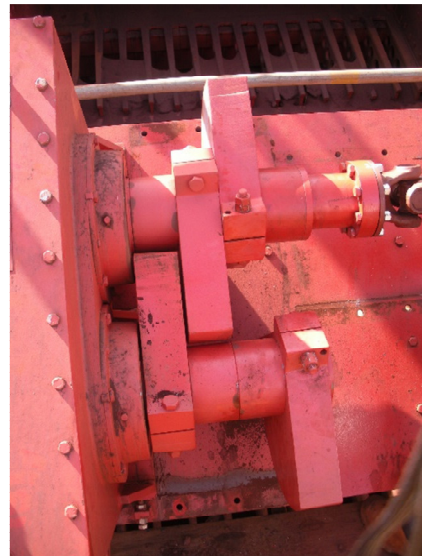
Inorder to reduce the out of balance forces acting on the screen, the position of the adjustable counterweight was moved from key position 0 (both reference and counterweight aligned, or 100% centrifical load) to key position 3, which corresponds to a an applied load of roughly 70% of maximum.

Photos No 14 and 15: Original and re-oriented position of counter weights on actuator.

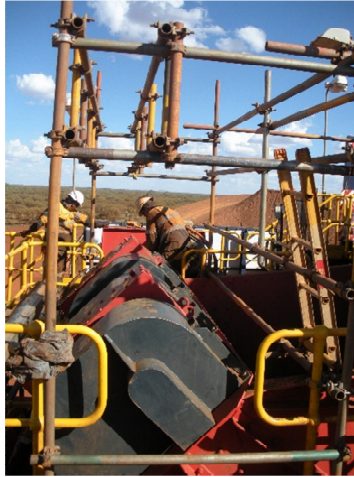
Photo No 16: Scaffolding built to provide a work platform along the excitor unit

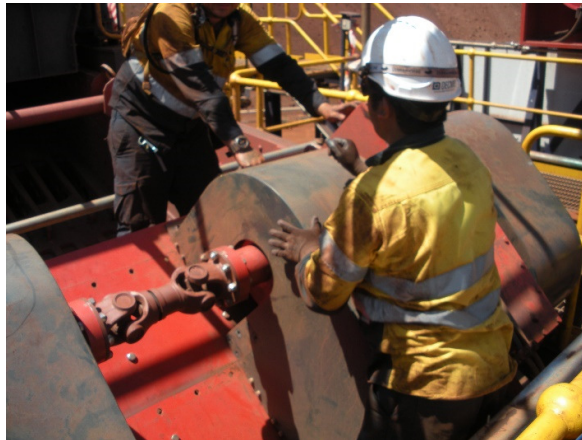
Photo No 17: Gaurds and covers being removed

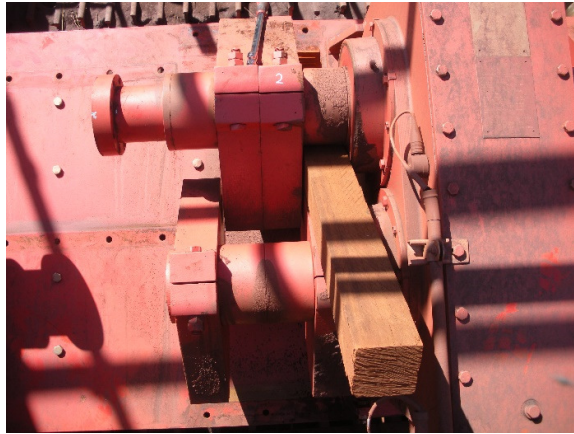
Photo No 18: Counter weights chocked to prevent rotation during work operations

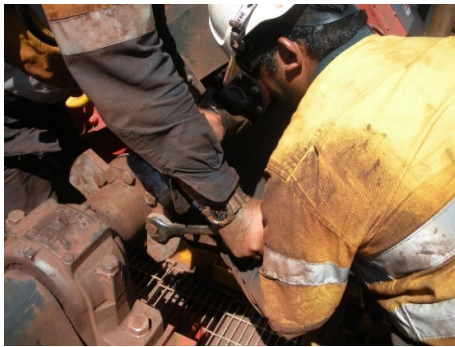
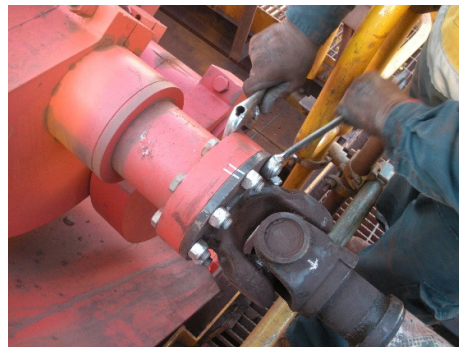
Photos No 19 and 19A: Universal shafts being removed

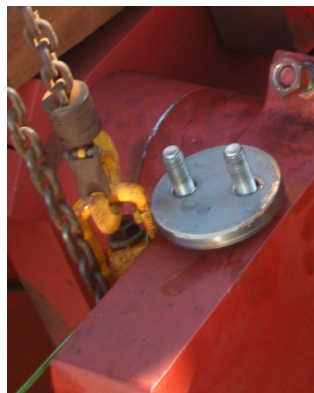
Photo No 20: Outer Counterweight locking plate removed

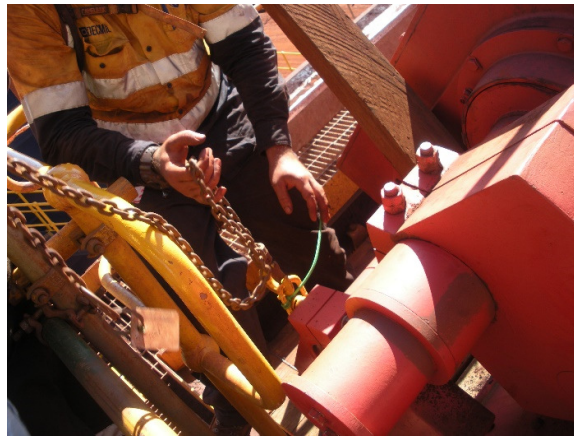
Photo No 21: Lifting attachment fitted to counterweight

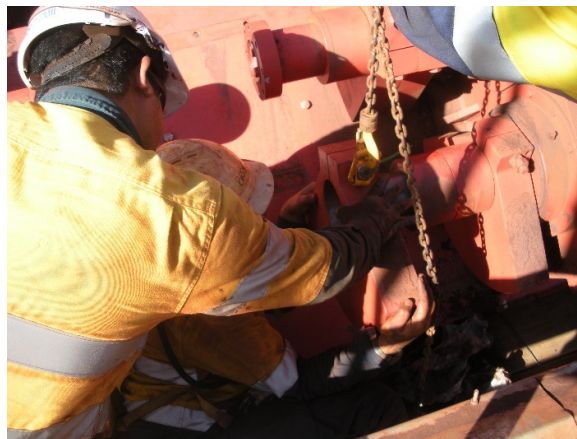
Photo No 22: Outer Counter Weight removed from keyway and shaft

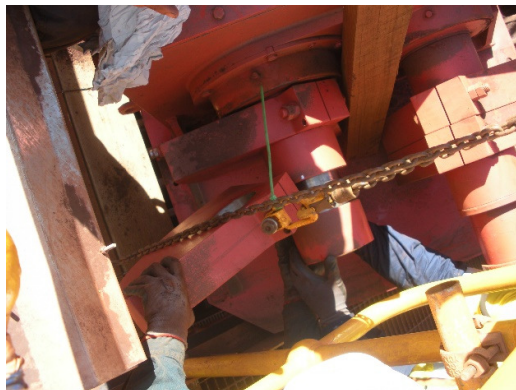
Photo No 23: Spacer piece removed from shaft

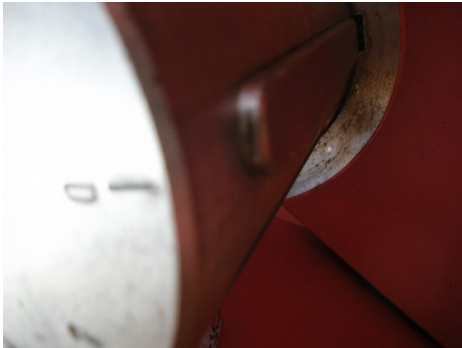
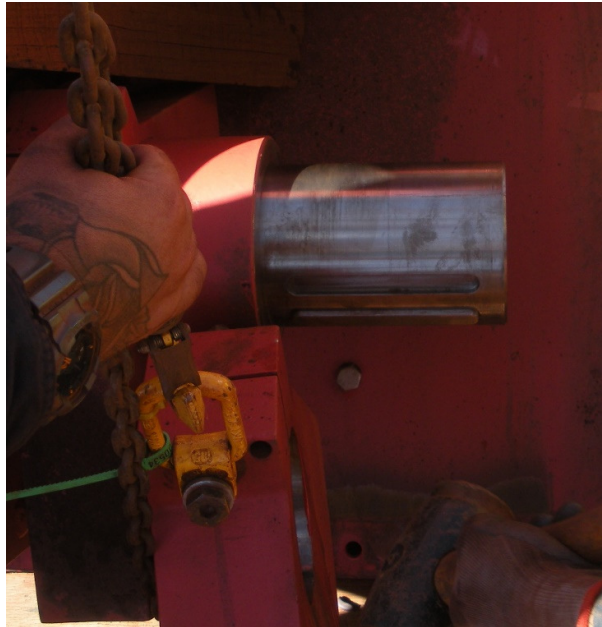
Photos No 24 and 24A: Key repositioned in drive shaft

- The key was removed from the keyway position '0', cleaned and dressed as required and repositioned in keyway position '3'

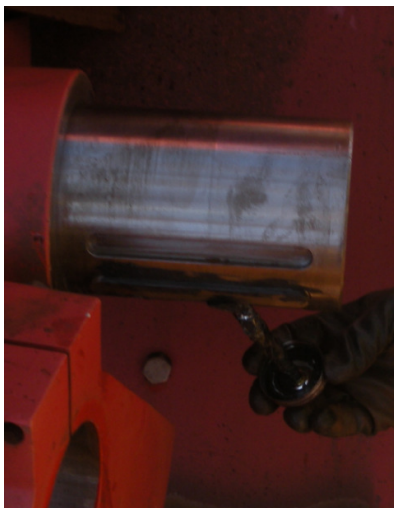
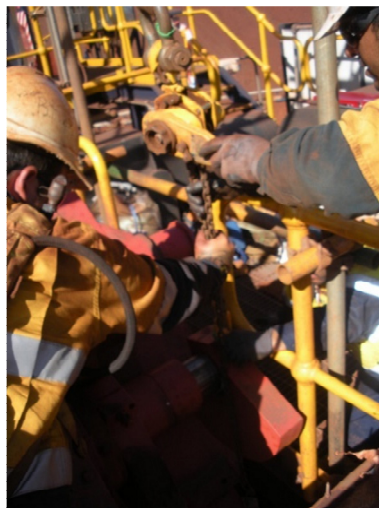
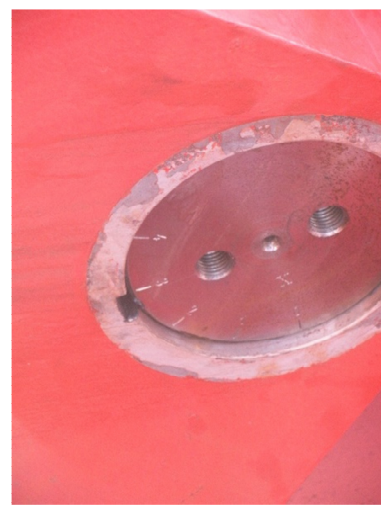
Photos No 25, 25A, 25B: Outer Counterweight being refitted to new position

- After thoroughly cleaning all the components, and coating with anti sieze (the key and inner bore of all the components), the spacer and counterweight was rotated and re-fitted to its new position. A zinc based anti-sieze agent was used on keys and keyways and a high viscosity oil / high impact grease emulsion was used on shaft and bore surfaces.

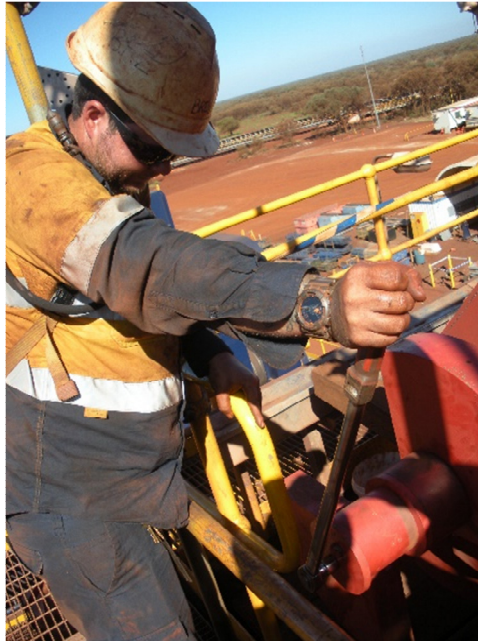
Photo No 26: Locking plate being torqued

- The counterweight clamping bolt was refitted, the locking plate replaced and torqued up to 210 Nm in accordance with specifications contained in section 8.13 of the OEM manual.

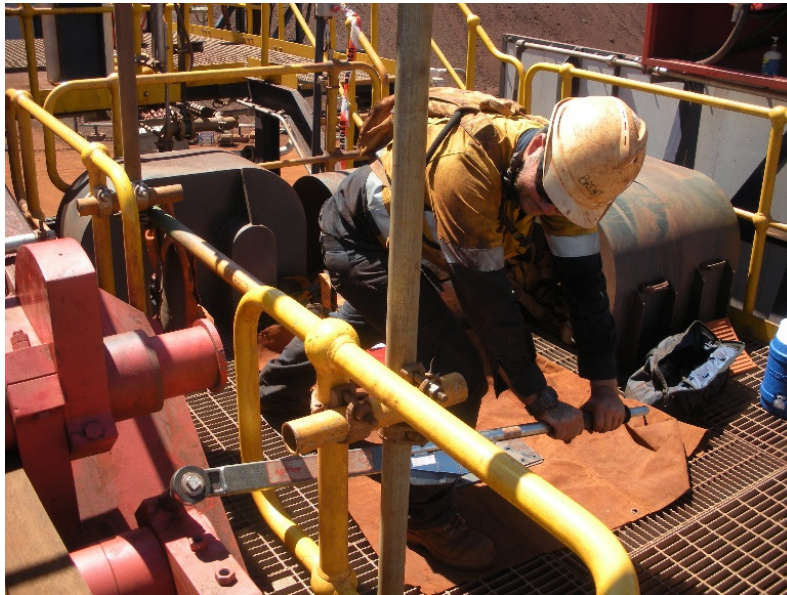
Photo No 27: Clamping bolt on Outer Counterweight being torqued.

- The Counter Weight clamping bolt was torqued to 415 Nm in accordance with specifications contained in section 8.13 of the OEM manual.

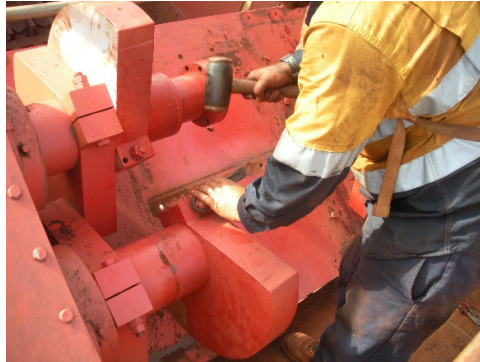
Photo No 28: Counter Weight clamping bolt lock nut being tensioned.

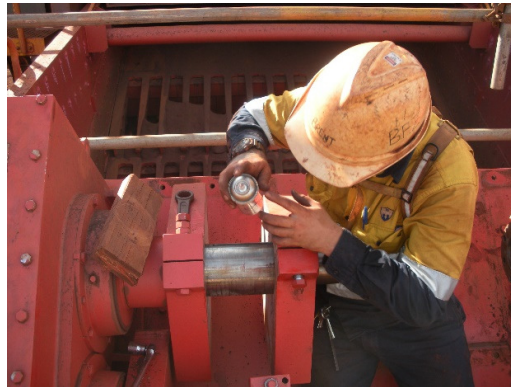
Photo No 29: Top Excitor Counter Weight being re-orientated

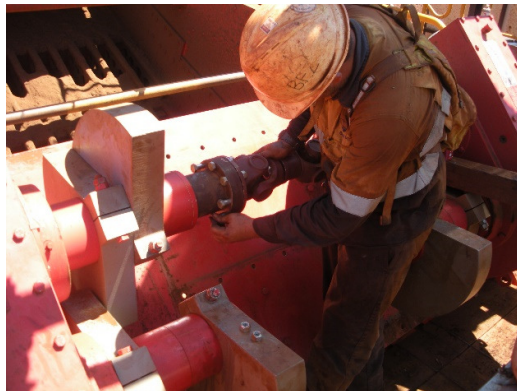
Photo No 30: Inter Gearbox drive shaft being refitted

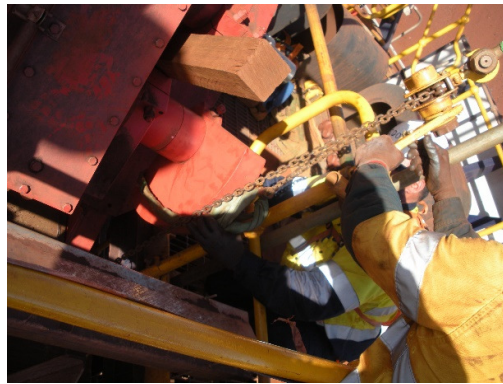
Photo No 31: Counter Weight assemblies being lifted to remove chocks

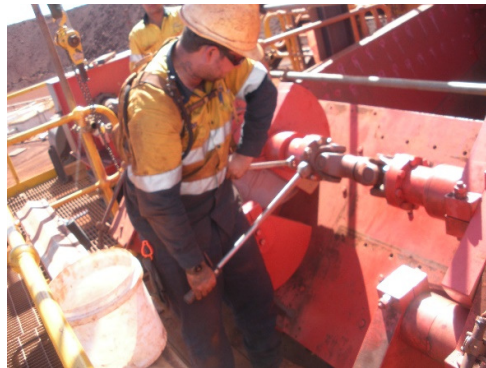
Photo No 32: Inter Gearbox being torqued after weight assemblies in neutral position

- The drive shaft bolts were torqued to 210 Nm in accordance with specifications contained in section 8.13 of the OEM manual.

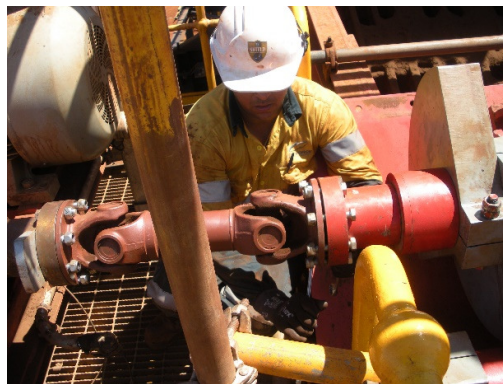
Photo No 33: Main Drive Shaft being fitted

- The main drive shaft was aligned and fitted. This was also torqued to 210 Nm in accordance with specifications contained in section 8.13 of the OEM manual.

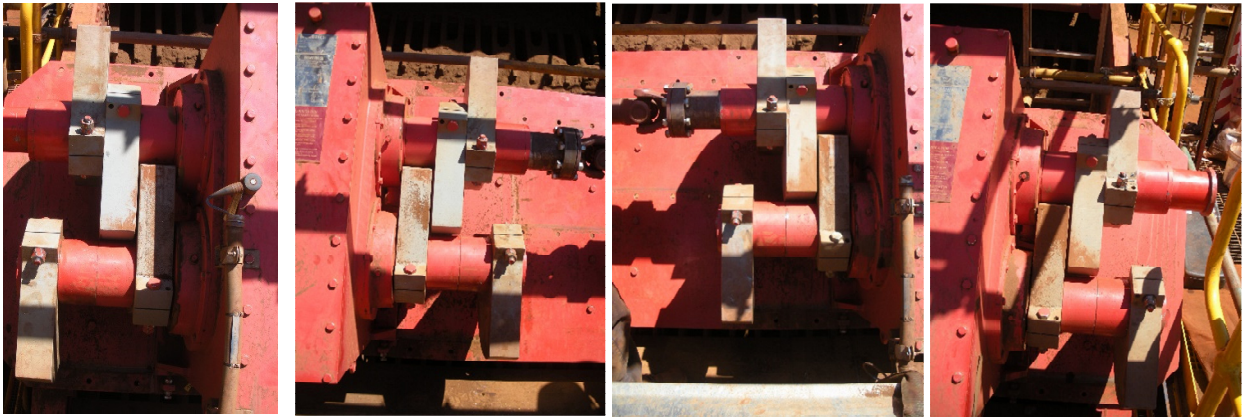
Photo Nos 34, 34A, 34B, 34C: Alignment of Counter Weights after re-orientation

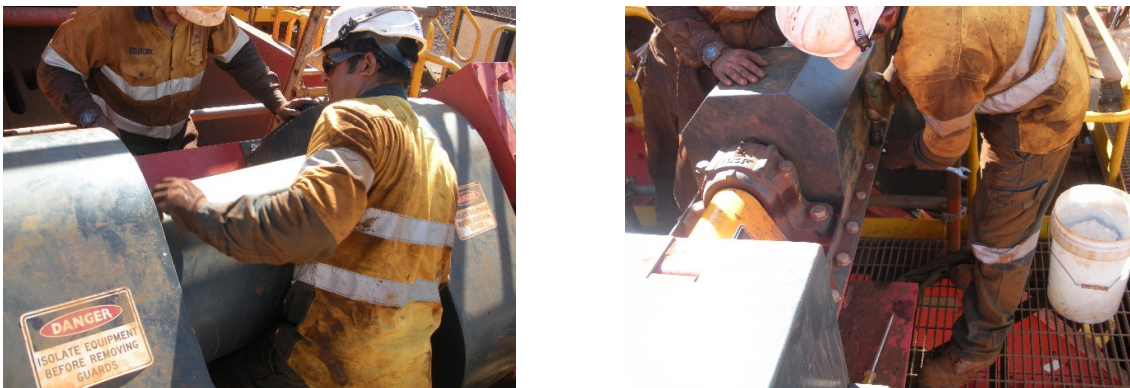
Photo Nos 35, 35A: Guards and covers re-fitted

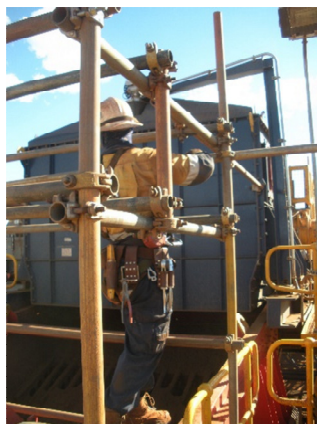
Photo No 36: Scaffolding being broken down

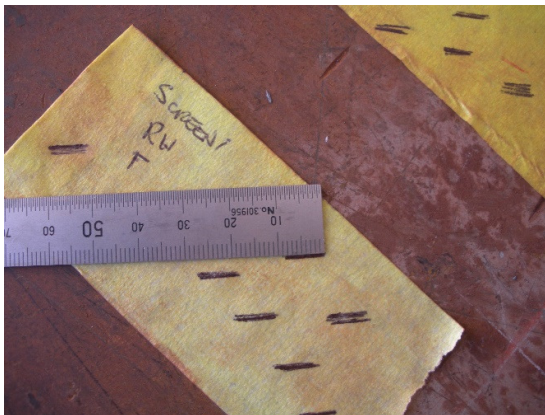
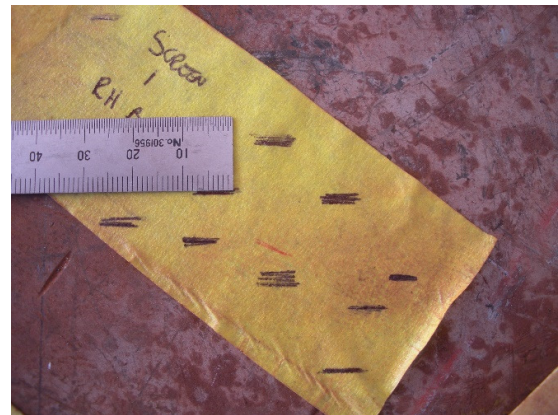
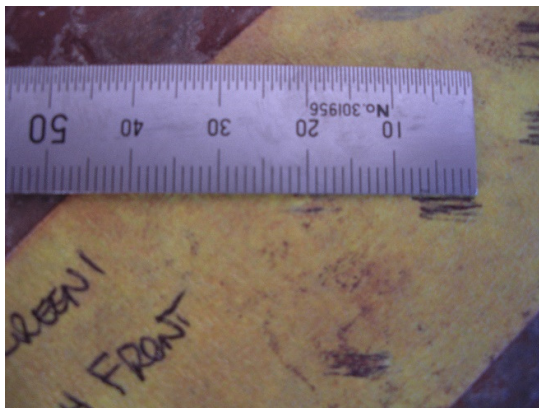
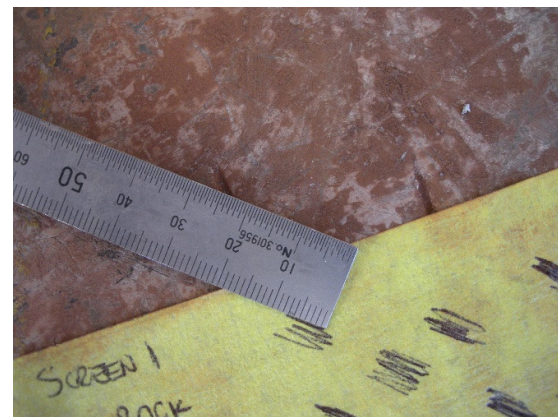
Screen 101 was found to have a reduced stroke of about 8 mm consistently around the machine line, while screen 301 was found to have a stroke of between about 8,0mm and 8,4mm

Photo Nos 42,42A,42B,42C: Screen 101 amplitude measurements recorded at the four corners of the screen.

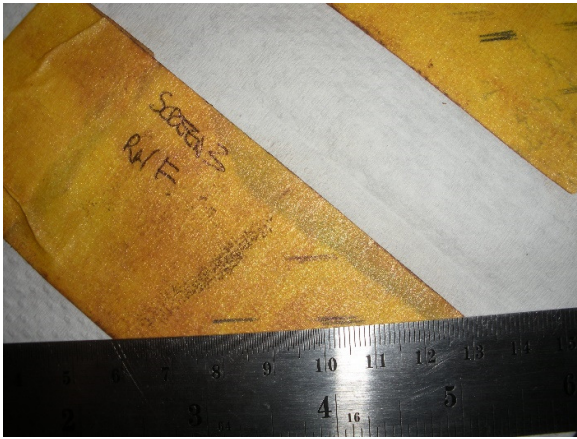
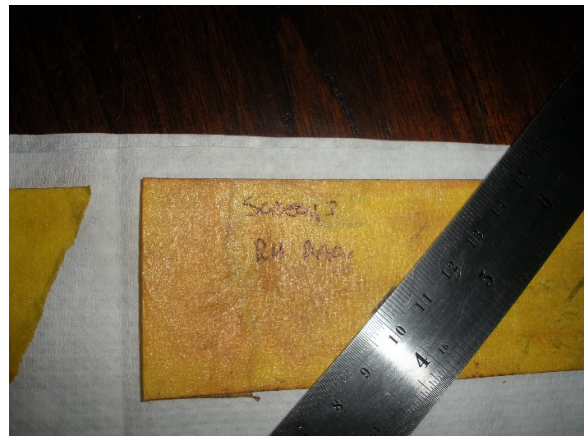
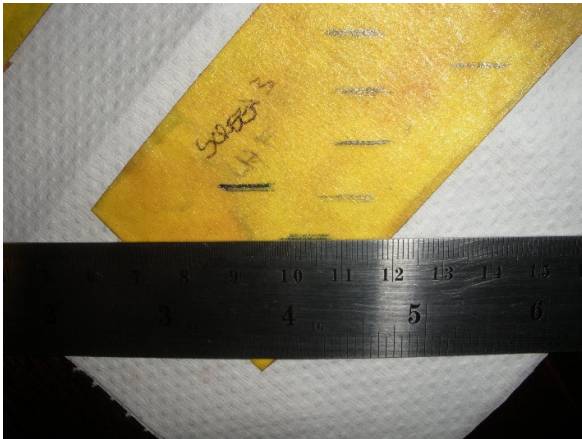
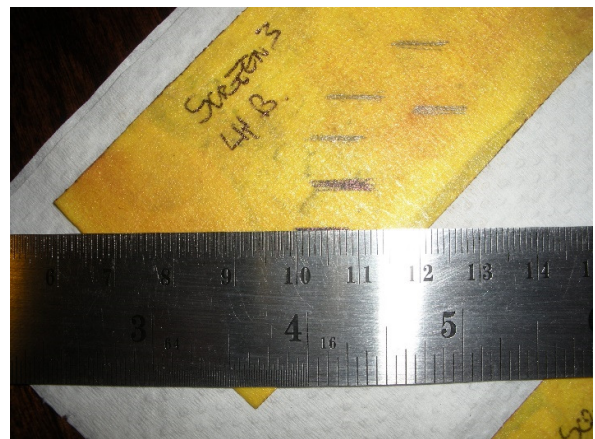
Photo Nos 43,43A,43B,43C: Screen 301 amplitude measurements recorded at the four corners of the screen.
